Brocade Fabric OS v6.3.2e Release Notes v1.0

November 22, 2011

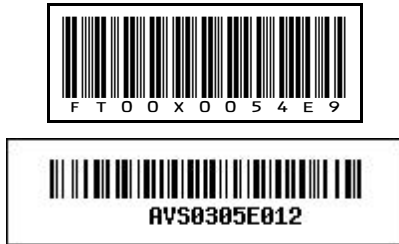
The switch serial number is provided on the serial number label, examples of which are shown here:

The serial number label is located as follows:

- Brocade 4100, 4900, and 7500/7500E – On the switch ID pull-out tab located inside the chassis on the port side on the left
- Brocade Encryption Switch, VA-40FC, 300, 5000, 5100, and 5300 – On the switch ID pull-out tab located on the bottom of the port side of the switch
- Brocade 7600 – On the bottom of the chassis
- Brocade 7800 – On the pull-out tab on the front left side of the chassis underneath the serial console and Ethernet connection and on the bottom of the switch in a well on the left side underneath (looking from front)
- Brocade 8000 – On the switch ID pullout tab located inside the chassis on the port side on the left and also on the bottom of the chassis.
- Brocade 48000 – Inside the chassis next to the power supply bays
- Brocade DCX – Bottom right of the port side
- Brocade DCX-4S – Back, upper left under the power supply
